WAVE

Number 173

June 2021

The Newsletter of the Barque Polly Woodside Volunteers Association Inc.

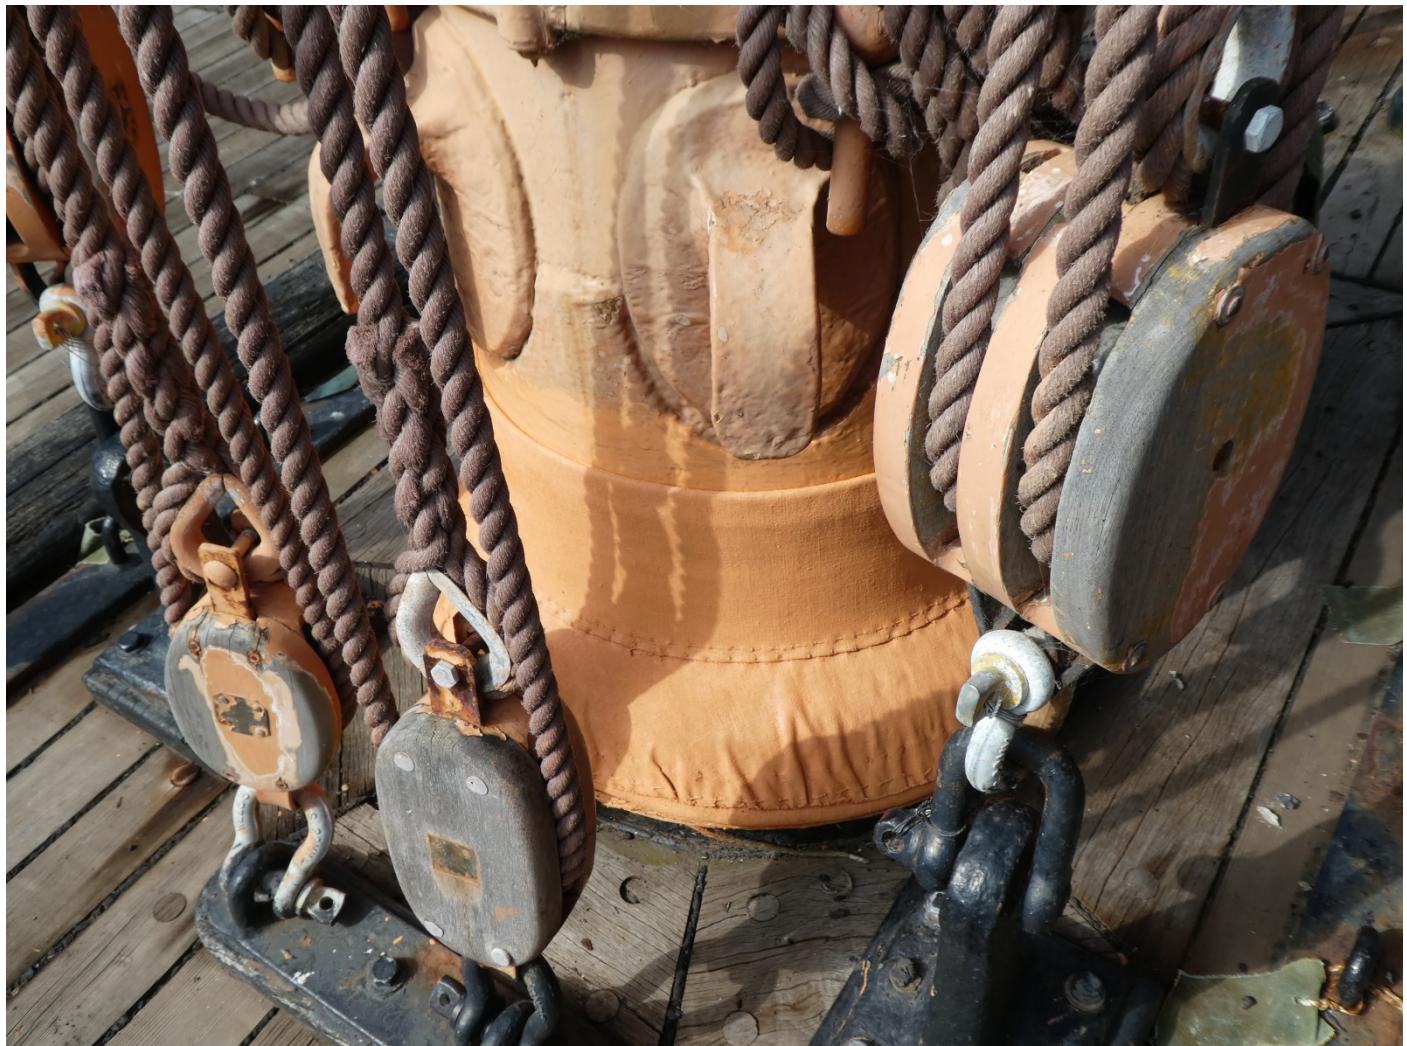
The Completed Main Mast-Coat.

16-Fore, Main and Mizzen Lower masts- A thorough inspection is needed, several lower shrouds needs servicing and slushing, deadeyes need scraping, inspection and coatings. The mast coats have been completed, the rest of the masts should be spot repaired and painted.
